# FAUNA MANAGEMENT PLAN

## ARROWSMITH NORTH SILICA SAND PROJECT

**Document Number: VRX-ARN-PLA-02**

Arrowsmith Silica Sand Project  
**REHABILITATION STRATEGY**

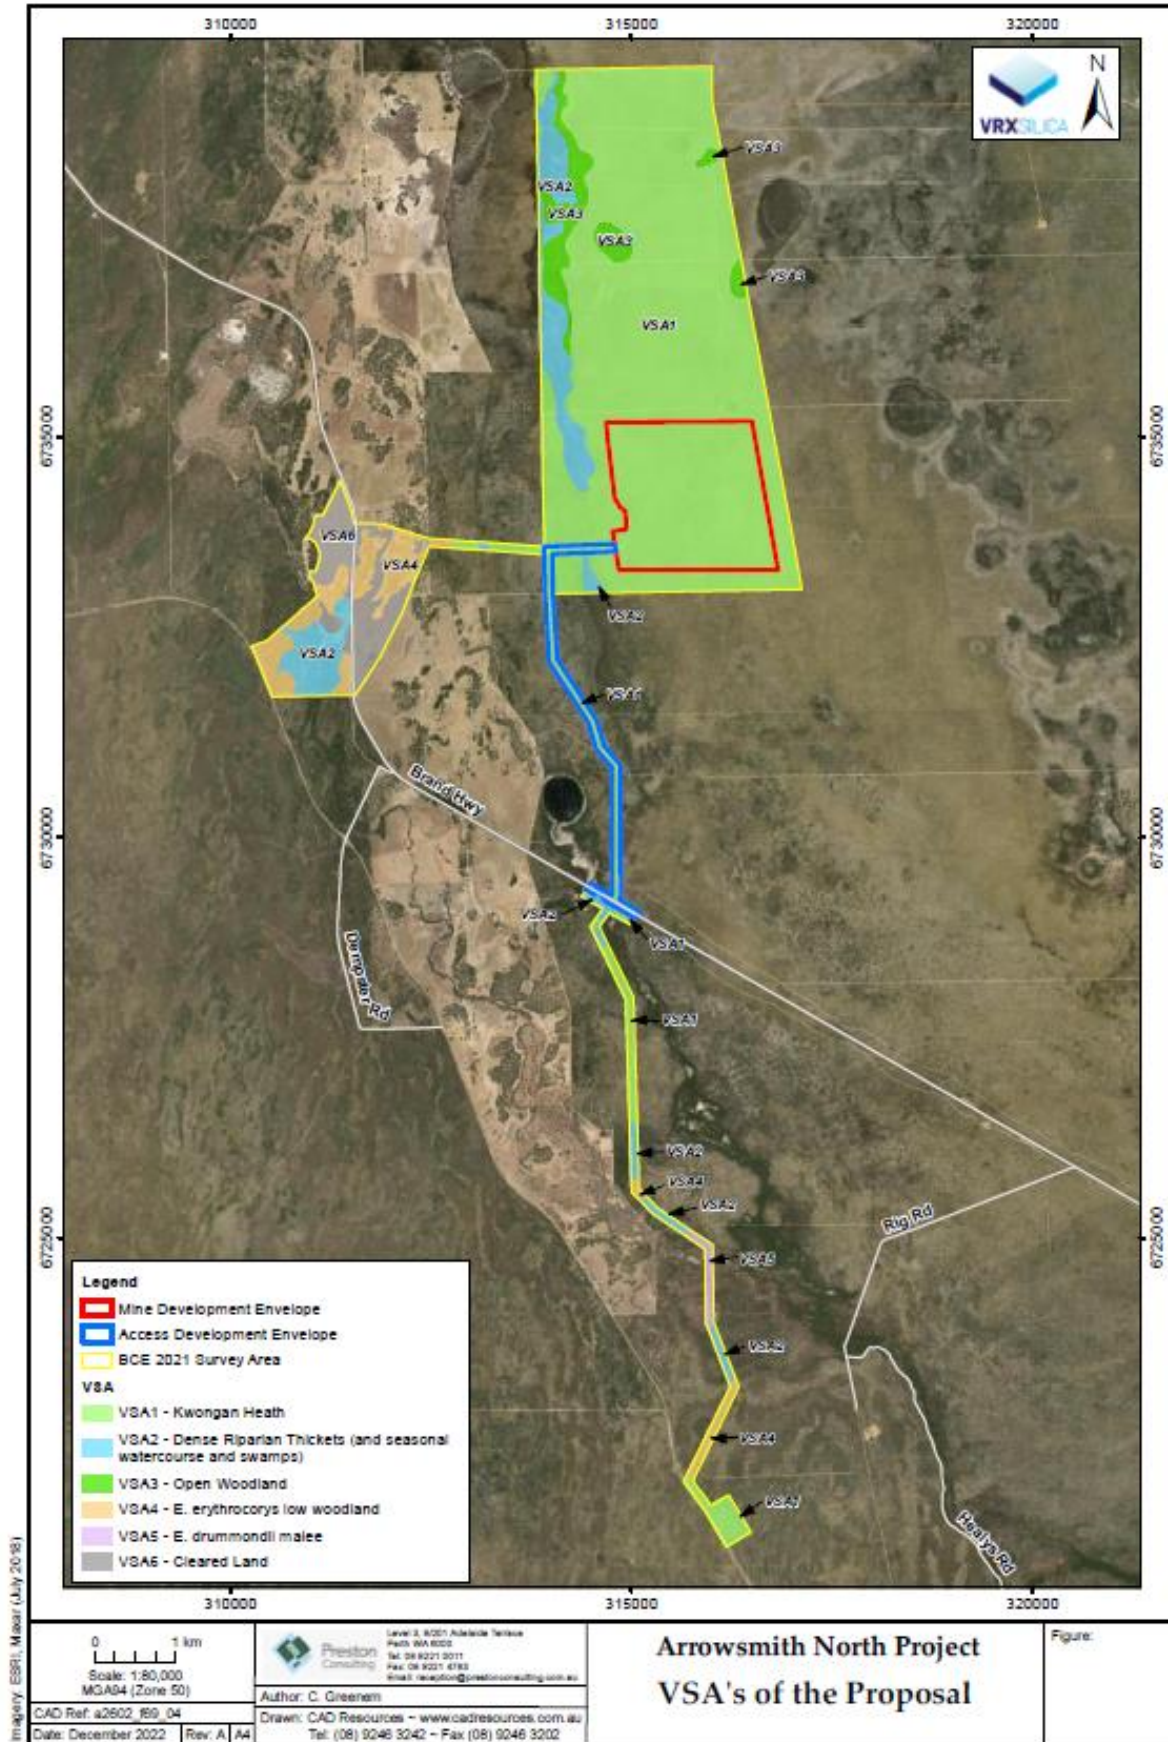
Figure 2: VSAs within the Survey Area

Bamford Consulting Ecologists (BCE; 2022) identified three VSA's within the Survey Area (Figure 2) and the descriptions and extents of these VSAs are detailed in Table 4. VSAs combine broad vegetation types, the soils or other substrates with which they are associated, and the landform. In the context of fauna assessment, VSAs are the environments that provide habitats for fauna.

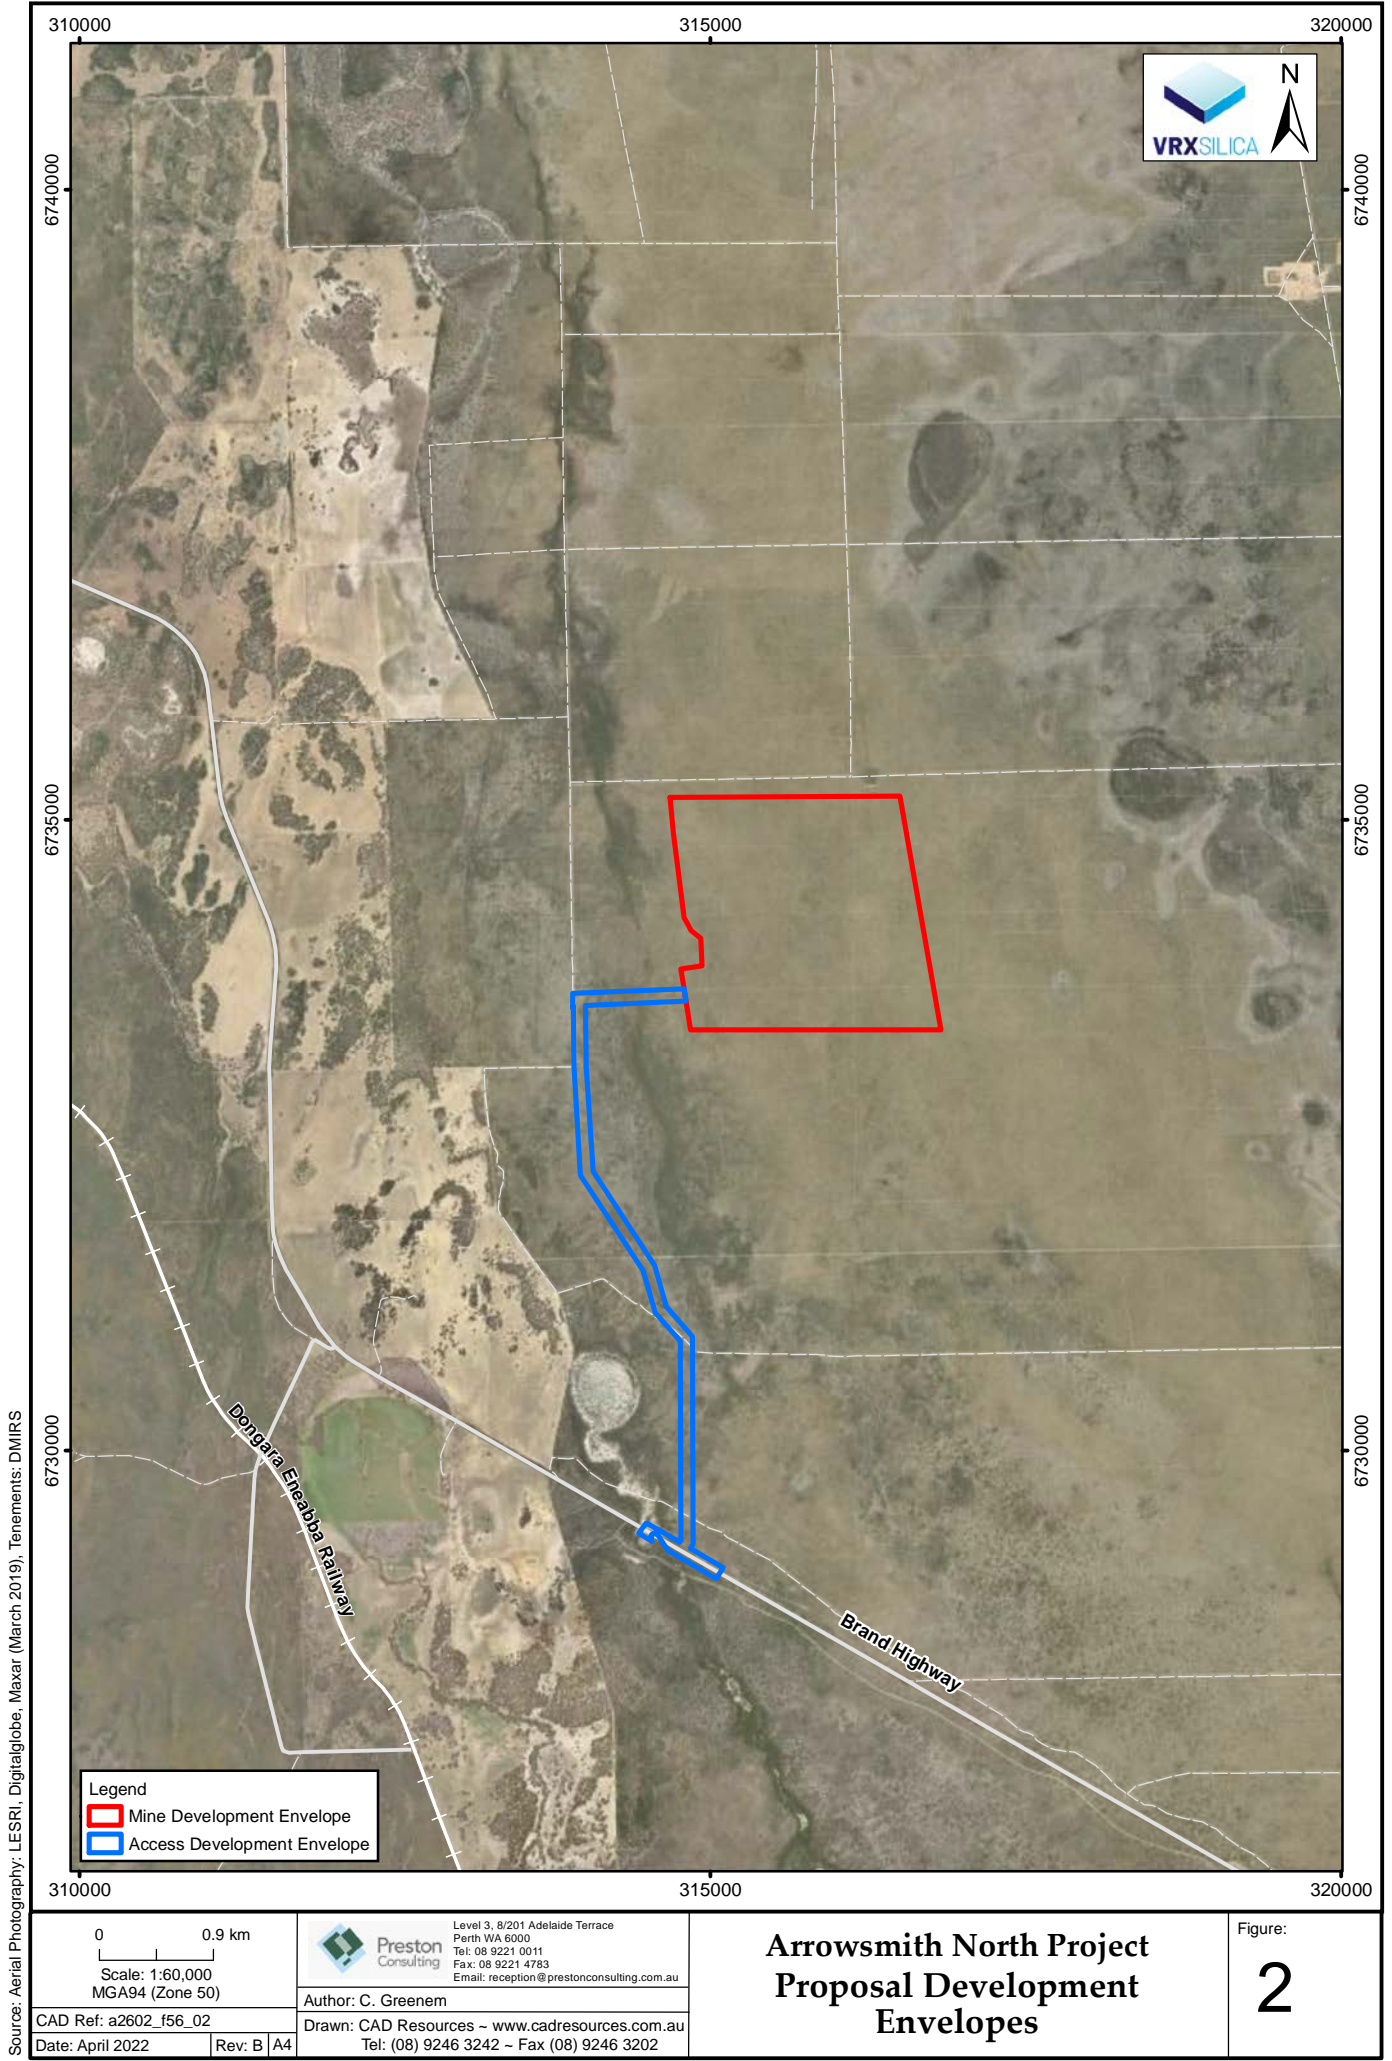
Figure 2: Development envelopes and indicative disturbance footprint of the Project

The Project is comprised of two development envelopes, the Mine Development Envelope (MDE) and the Access Development Envelope (ADE). The development envelopes and proposed disturbance footprint (Figure 2) have been selected to exclude unique vegetation that may contain priority flora and vegetation that provide suitable Carnaby's Black Cockatoo breeding and roosting habitat. Furthermore, cleared land and areas of degraded vegetation were favoured during the access corridor design.

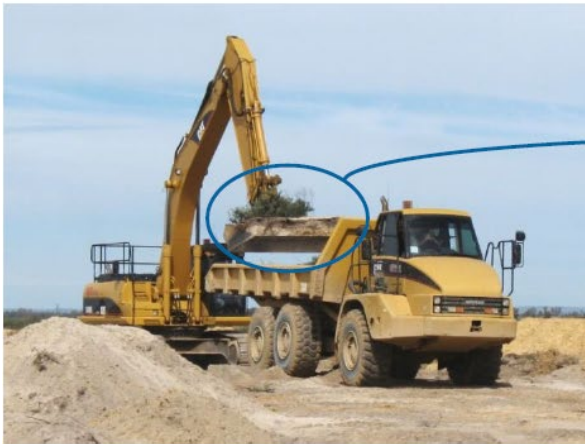
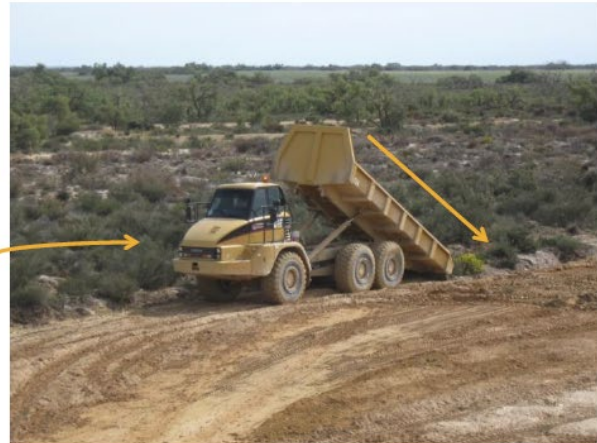
Figure 4: VDT method used for Iluka Eneabba VDT trial (from Dobrowolski 2016)

Historically, excavators with conventional bucket attachments have been used for VDT (Figure 4). This machinery has the potential to fragment the sod, exposing roots to the air and therefore requires a high degree of operator skill to ensure the structural integrity of sods are maintained. With improved machinery, in this case a purpose-built wide mouth front end loader attachment (measuring 3 m x 3 m x 40 cm), as depicted in Figure 5, reduced scope of operator error and better control will increase the likelihood of successful VDT.

Vegetation and 30–40 cm of the intact topsoil profile was excavated...

...and transferred to a ripped subsoil surface

1.6 hectares transferred

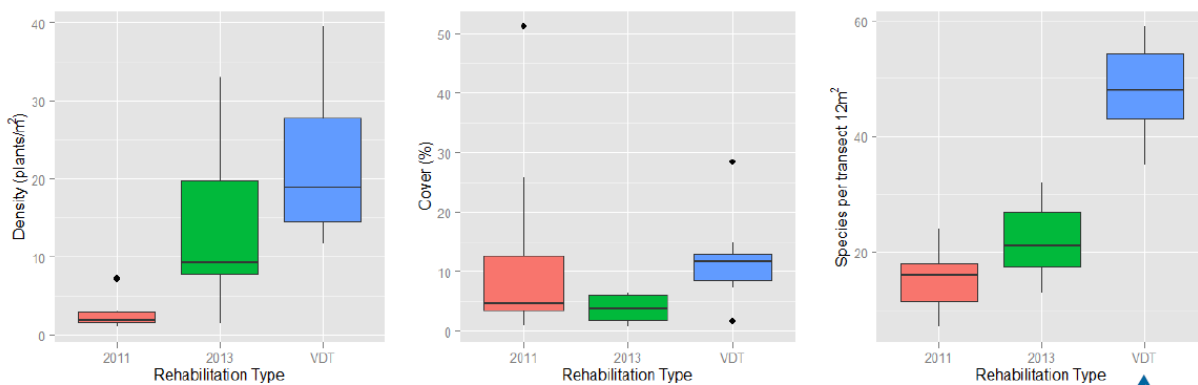
**Figure 6: Simple vegetation metrics on Eneabba VDT (from Dobrowolski, 2016)**

Species diversity is **2.5–3 times greater** over the same spatial scale

VDT performance exceeds standard rehabilitation practice (complete removal of above-ground components, stripping topsoil with a scraper or equivalent, stockpiling or direct replace, soil erosion protection, seeding and infill planting) when measured after three years using simple vegetation metrics (Dobrowolski, 2016) (Figure 6). In particular, the comment that species diversity is 2.5-3 times greater (than in comparison to conventional mine rehabilitation) Vegetation density, ground cover and presence of recalcitrant species provide further evidence of the superior outcomes of VDT over conventional mine rehabilitation (Figures 7,8,9,10).

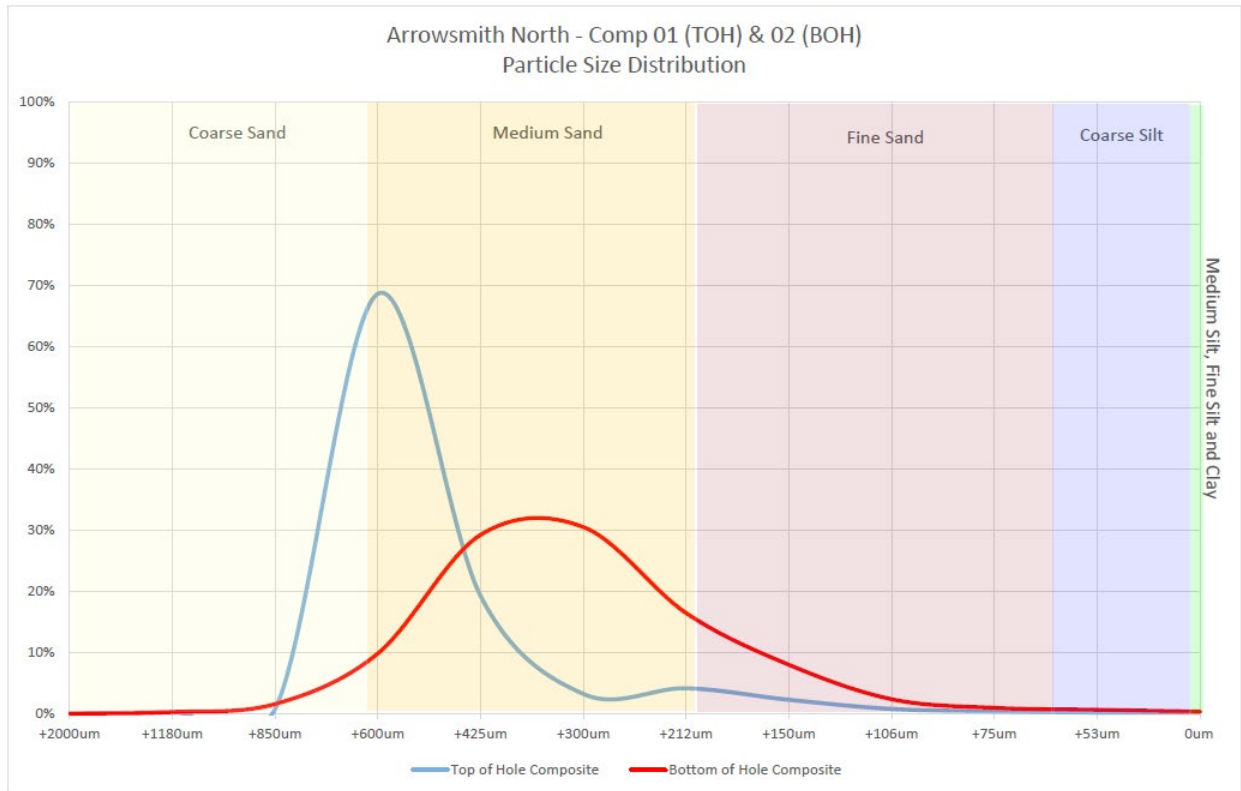
**Figure 16: Top and Bottom of Profile PSD - North**

Using the ISO 14688-1:2002 classification scheme (Appendix 2) to describe the particle size categories, a comparison of the composite samples from the north, mid and south all show minimal difference in soil classification (Figure 16 to Figure 18). All samples retaining a classification of ‘medium sand’. The material at the base of the pit will become the subsoil in the rehabilitation profile, and subsoil classification is not changing from sand to clay, or even silt. The lack of clay particles in the samples is also notable – all samples show particle size portions of less than 52 µm (approximately fine silt) represent 0.3% or less of the sample.
